# Blockage in the Merger

This issue arises when filament gets jammed in the merger portion of your Palette, which will cause your drives to not feed filament through your Palette.

Written By: Mosaic Support

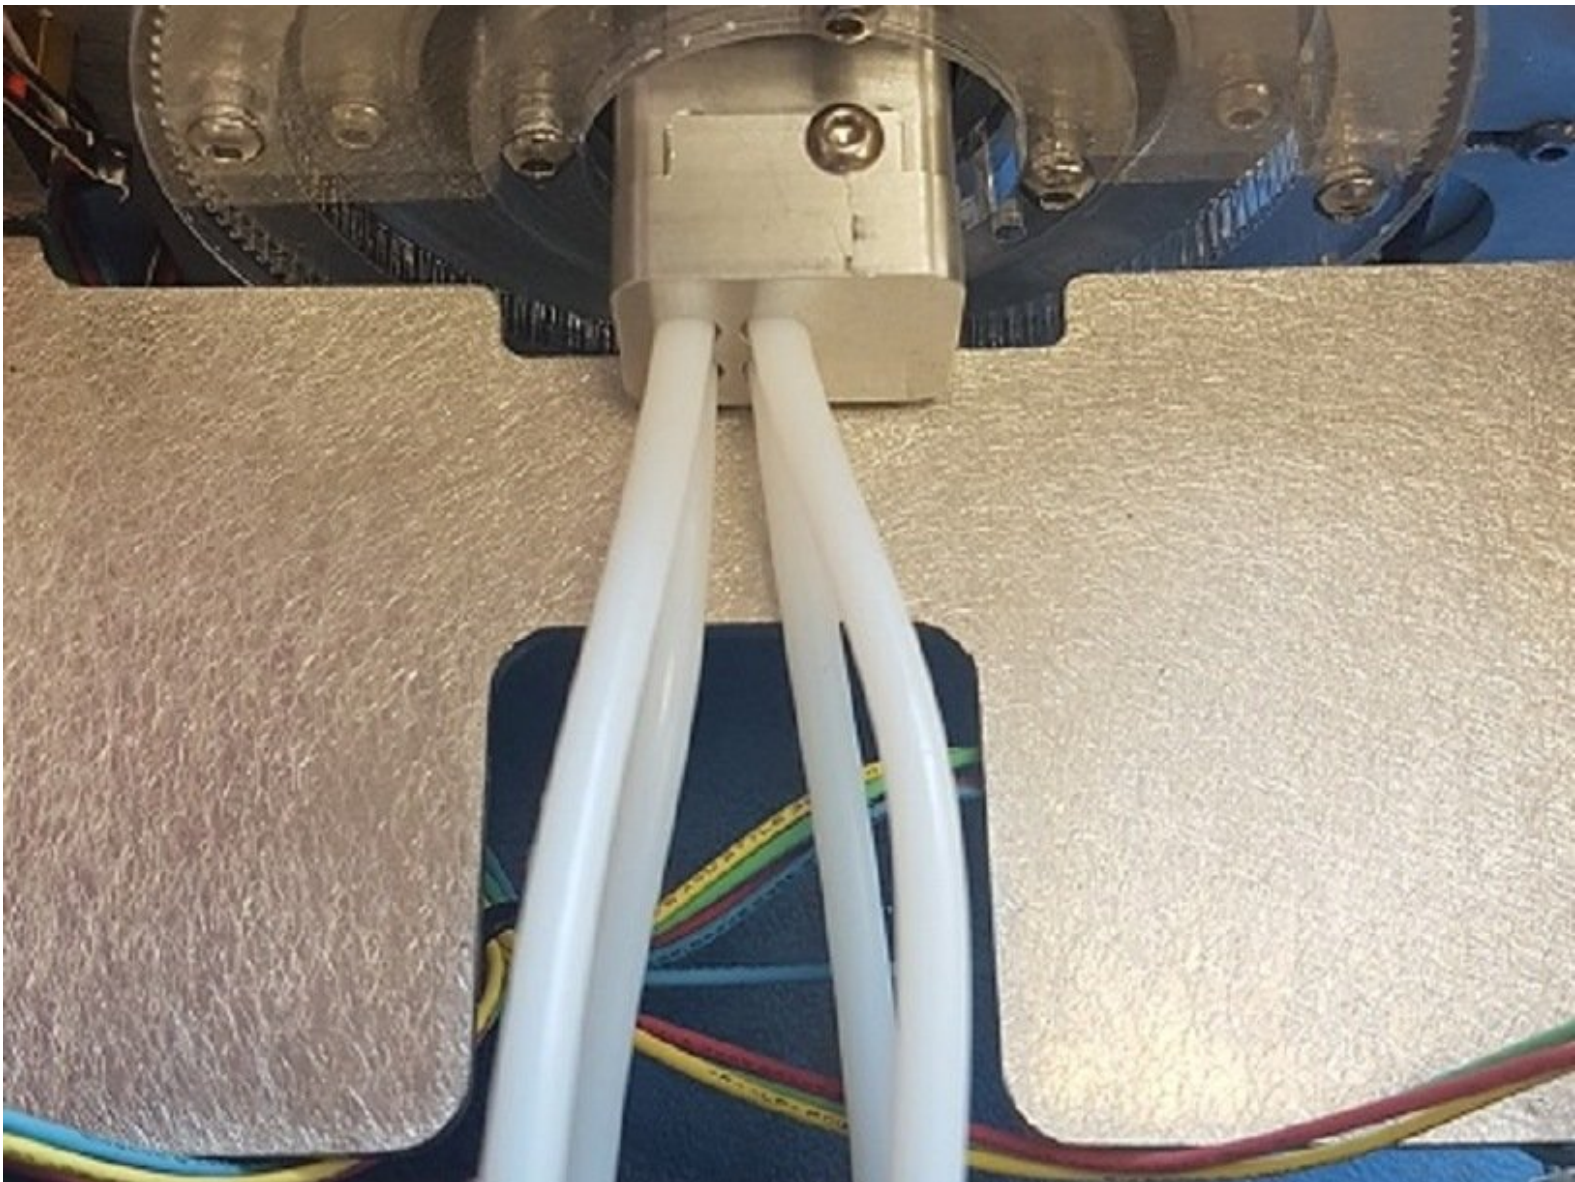
This issue arises when filament gets jammed in the merger portion of your Palette/Palette+, which will cause your drives to skip and will not feed filament through to the cutter or splicing portions of Palette. This usually happens if your filament is brittle and breaks off while it is being pushed through Palette, or if a short piece of filament is fed into Palette (such as at the end of a spool).

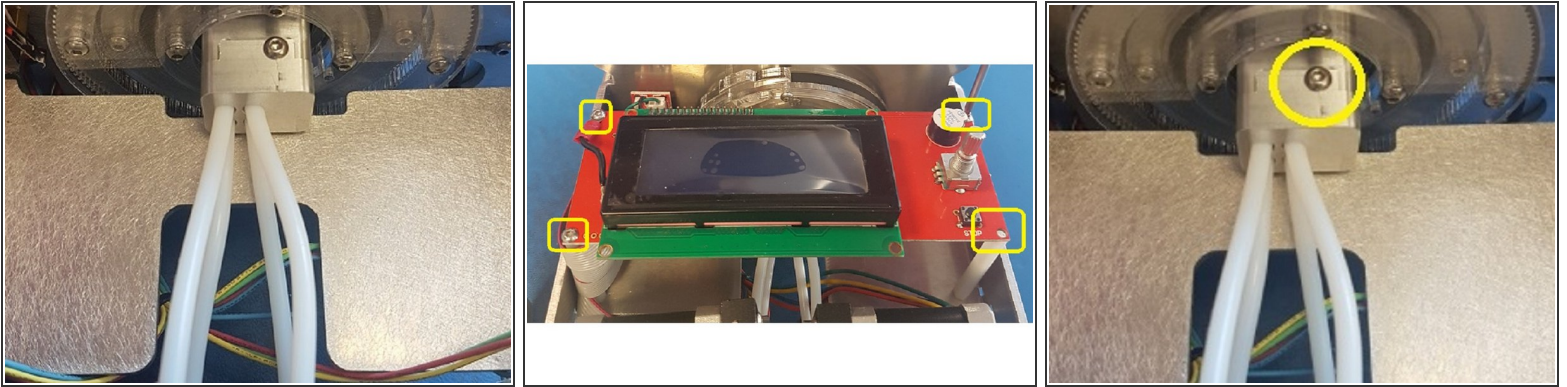
## Step 1 — Palette+ Merger

- Remove the top lid of your Palette+ by removing the top two screws on each side of your unit. Next, detach the screen by removing the 4 screws using the same 2.0 mm hex key.
- Once the screws are removed the screen is still connected to Palette+, so carefully place this piece to the side and you'll have a clear path to the merger. Next, remove the one screw which attaches the merger to the cutter.

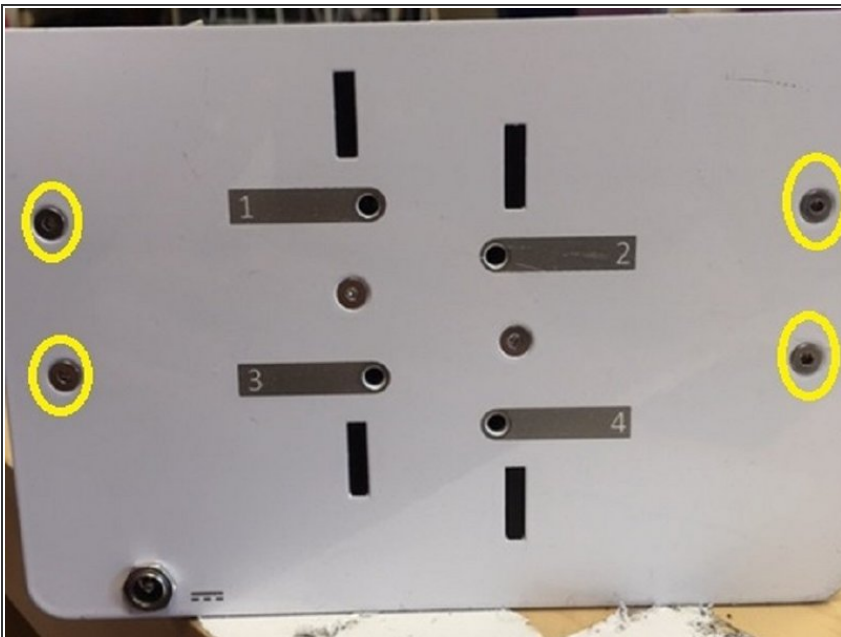
## Step 2

- Loosen the front plate of your Palette by removing the 4 screws and carefully removing the plate with the drives attached.
- Once this entire unit is loosened, you should be able to clear the blockage from your merger. You can do this by pushing a piece of filament through the merger's tubes. Once cleared, reverse the steps to reassemble your Palette carefully.

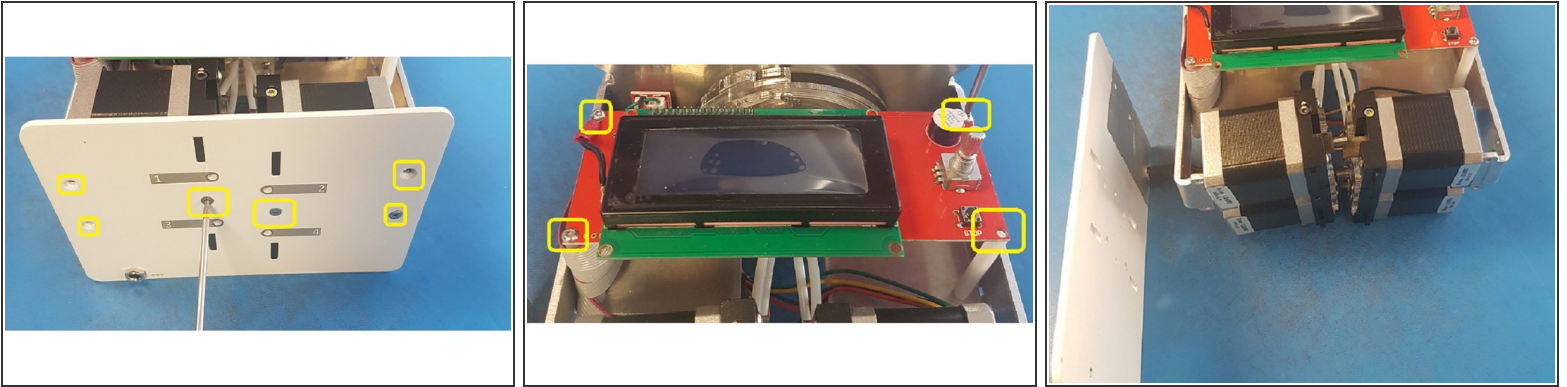
### Step 3 — Palette Merger

- Remove the top lid of your Palette+ by removing the top two screws on each side of your unit. Next, detach the screen by removing the 4 screws using the same 2.0 mm hex key.
- Remove the front plate of your Palette by removing the 6 screws and carefully removing the plate.
- You'll notice that we did not remove the DC barrel nut from the front plate. You can place the front plate to the side, still attached to the tether.
- Next, detach the screen by removing the 4 screws using the same 2.0mm hex key.

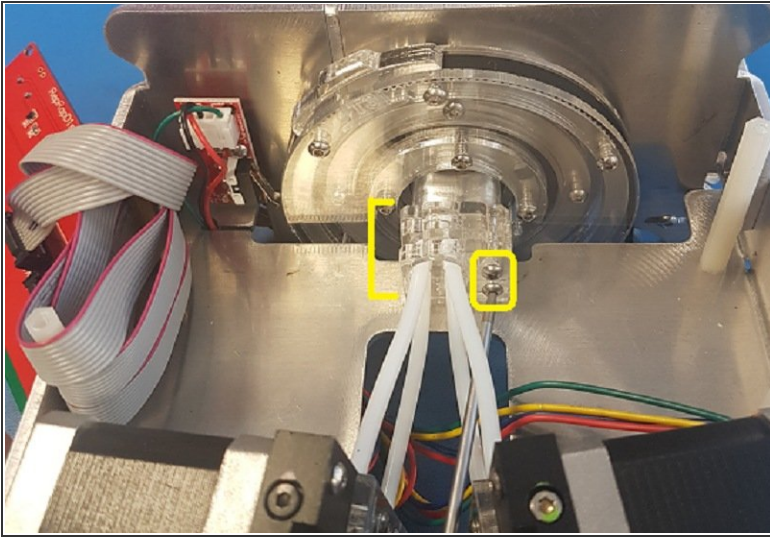
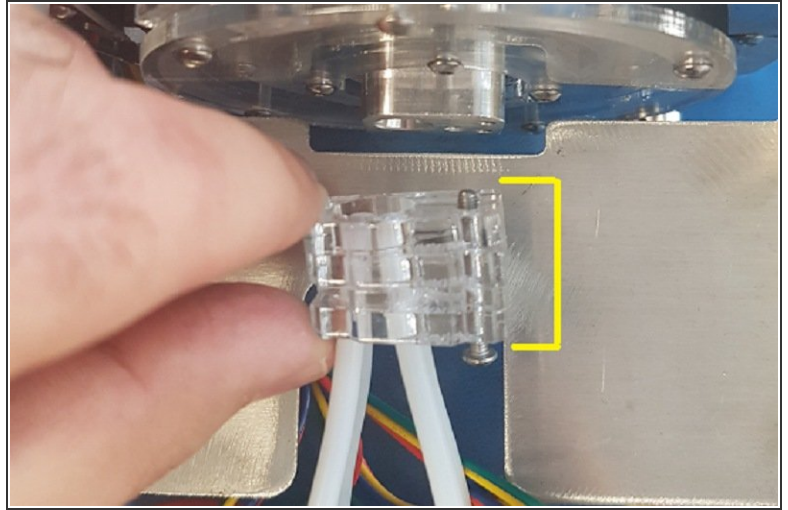
## Step 4

- Even once the screws are removed the screen is still connected, so carefully place this piece to the side and you'll have a clear path to the merger. Carefully shift the drives to the side so that you can access the two screws which attaches the merger to the cutter. Be sure to hold the acrylic pieces together when removing these two screws.
- If they slip or are separated, refer to this [support article](#).
- Once you free the acrylic piece, you should be able to clear the blockage from your merger! Once this is cleared, reverse the steps to reassemble your Palette carefully.
